H&S Bosma Dairy Lagoon No. 3

H&S Bosma Dairy Lagoon No. 3 Abandonment Plan

Prepared for H&S Bosma Dairy

Anchor QEA, LLC
1119 Pacific Avenue, Suite 1600
Tacoma, Washington 98402

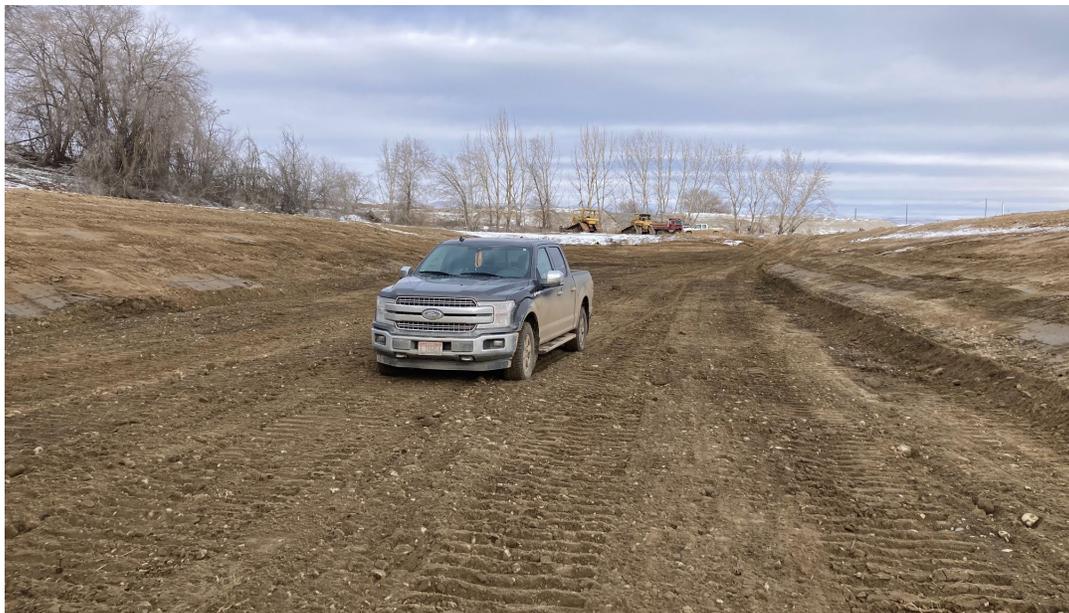
Photograph 1
Condition of Lagoon No. 3 in December 2021 Following Manure and Liquids Removal

Prior to sampling, the liquids and organic solids were removed from the lagoon. Liquids contained within the lagoon were transferred to an in-service, lined lagoon. After liquid removal, organic solids were removed and placed in the composting area. Solids were removed down to the current lagoon soil foundation material. The condition of the lagoon after manure removal is shown in Photograph 1.

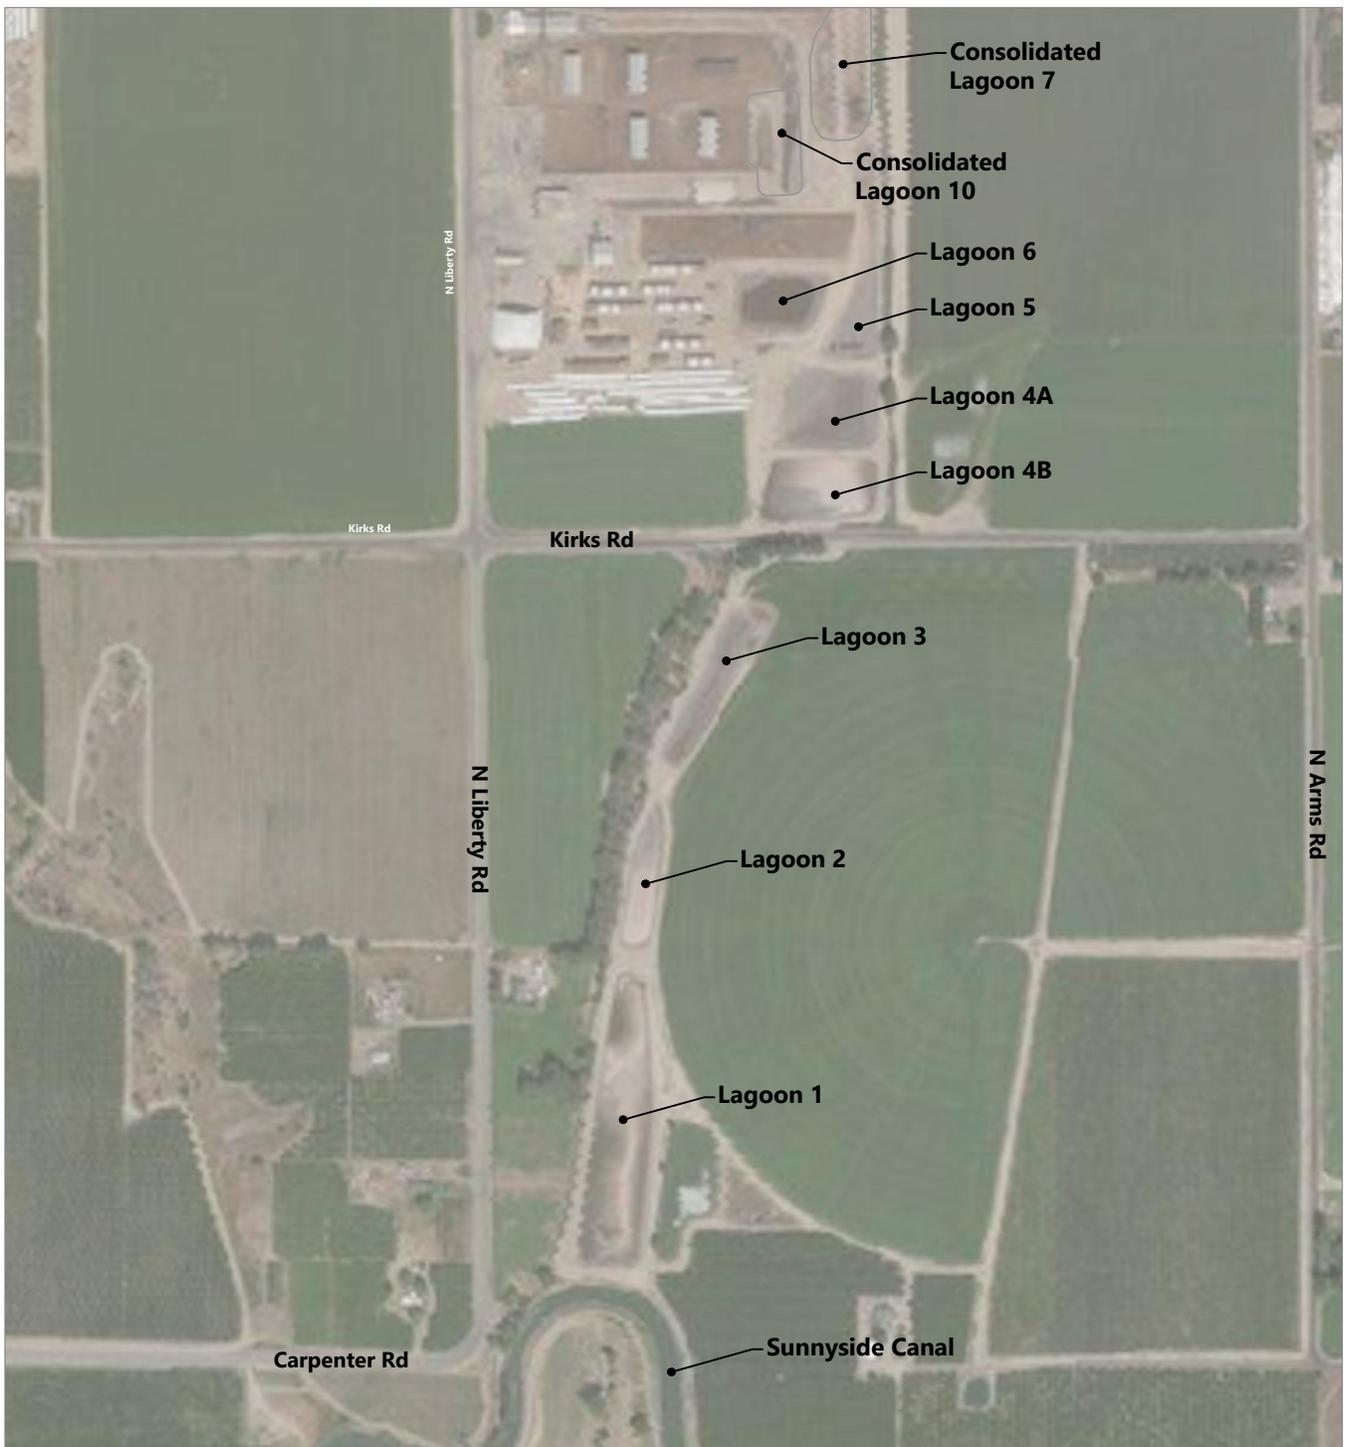
Figure 1
H&S Bosma Dairy Lagoon Map

The Dairy is located at 5860 East Zillah Drive Road in Granger, Washington. Figure 1 shows the location of Lagoon No. 3. The estimated dimension and capacity of the lagoon prior to abandonment are provided in Table 1.

The lagoon was originally created within a natural depression in the topography, bounded by Kirks Road and the Sunnyside Canal (owned by the Sunnyside Valley Irrigation District [SVID]), with the addition of earthen berms at the southern ends of what would become Lagoon No. 3. The lagoon is constrained by SVID drainage easement to the west, cropland to the east, Kirks Road to the north, and Lagoon No. 2 to the south.
